DEPARTMENT OF TRANSPORTATION

Quality Assurance and Source Inspection

Contract #: 04-0120F4Cty: SF/ALA Rte: 80 PM: 13.2/13.9File #: 69.28**WELDING INSPECTION REPORT****Resident Engineer:**Siegenthaler, Peter**Address:** 333 Burma Road**City:** Oakland, CA 94607**Report No:** WIR-022077**Date Inspected:** 01-Jan-2011**Project Name:** SAS Superstructure**OSM Arrival Time:** 700**Prime Contractor:** American Bridge/Fluor Enterprises, a JV**OSM Departure Time:** 1900**Contractor:** Zhenhua Port Machinery Company, Ltd (ZPMC), Changxing Island **Location:** Shanghai, China**CWI Name:** Liu Yang**CWI Present:** Yes No**Inspected CWI report:** Yes No N/A**Rod Oven in Use:** Yes No N/A**Electrode to specification:** Yes No N/A**Weld Procedures Followed:** Yes No N/A**Qualified Welders:** Yes No N/A**Verified Joint Fit-up:** Yes No N/A**Approved Drawings:** Yes No N/A**Approved WPS:** Yes No N/A**Delayed / Cancelled:** Yes No N/A**Bridge No:** 34-0006**Component:** OBG**Summary of Items Observed:**

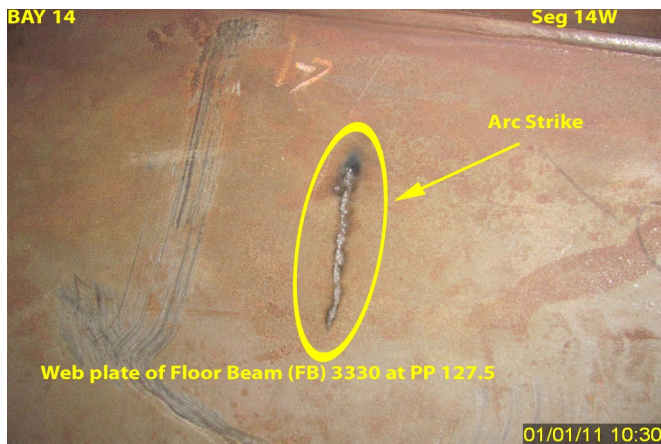
During random in process inspection of Orthotropic Box Girder (OBG) member identified as web plate of Floor Beam (FB) 3330A, this QA observed an arc strike on Piece Mark (PCMK) identified as FB 3330 at Panel point (PP) 127.5. This QA marked the affected area and informed ZPMC Quality Control (QC) identified as Mr. Zhu Lin of this issue. Mr. Zhu Lin informed this QA that the arc strike would be corrected in a manner compliant with the contract documents. Attached photograph provide additional detail.
